Appendix A – Reevaluation Statement #5

Project Design Modifications

I-69 Section 6 Contract 5
County Line Road
Modified Design
Draft - Not For Construction

WETLAND DELINEATION AND WATERS REPORT

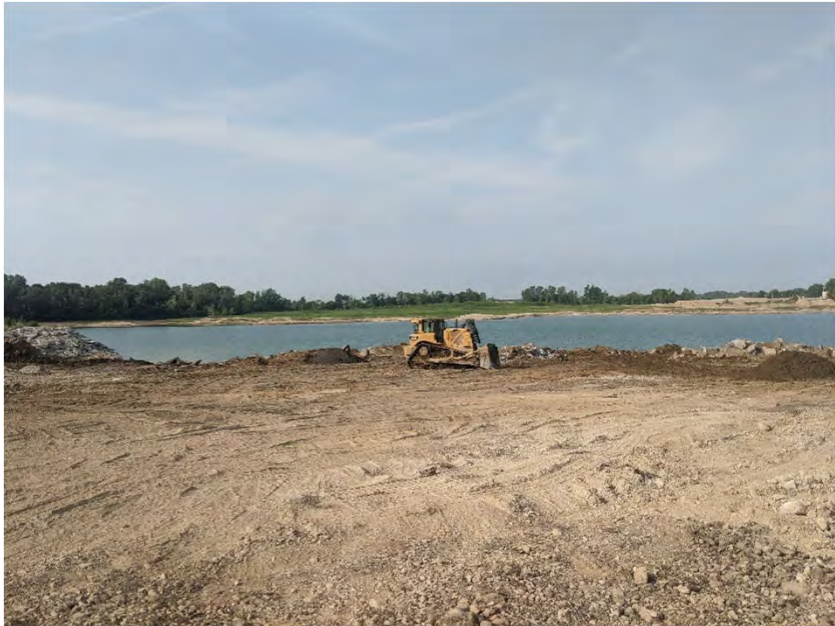
Photo 4. Looking southwest at the fill area of the manmade gravel pit within the investigated area.

A manmade gravel pit filled with water is located adjacent to the southern border of the investigated area within an active aggregate plant. The manmade gravel pit begins approximately 0.23 mile west of Belmont Avenue and approximately 0.05 mile south of Epler Avenue where it extends to the west and south. The manmade gravel pit was investigated due to it being mapped as a wetland within the investigated area on the NWI mapping. During the July 26, 2021 site investigation, it was observed that the manmade gravel pit is actively being filled with material and has decreased in size. The boundaries of the manmade gravel pit are no longer within the investigated area and it is now located south of the investigated area.

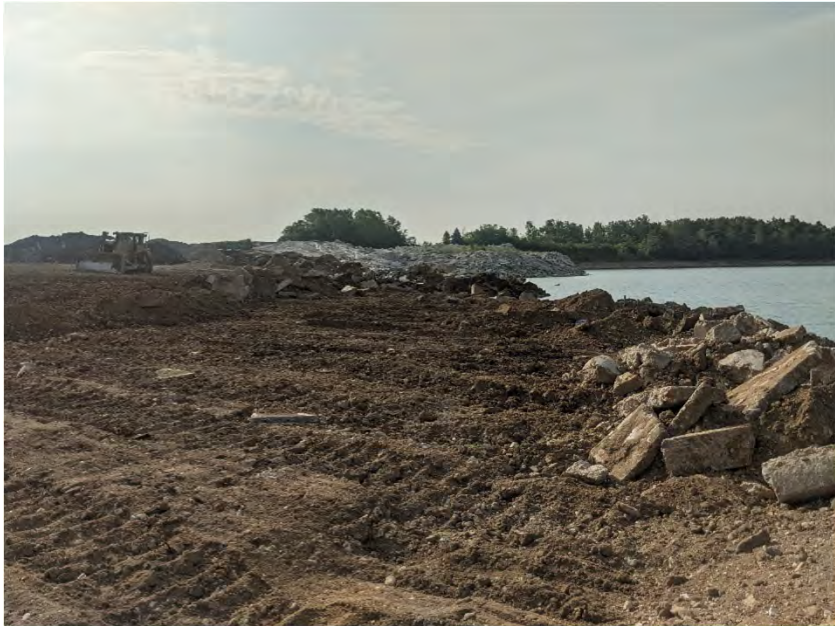
Photo 6. Looking south at the manmade gravel pit and the southern limit of the investigated area.

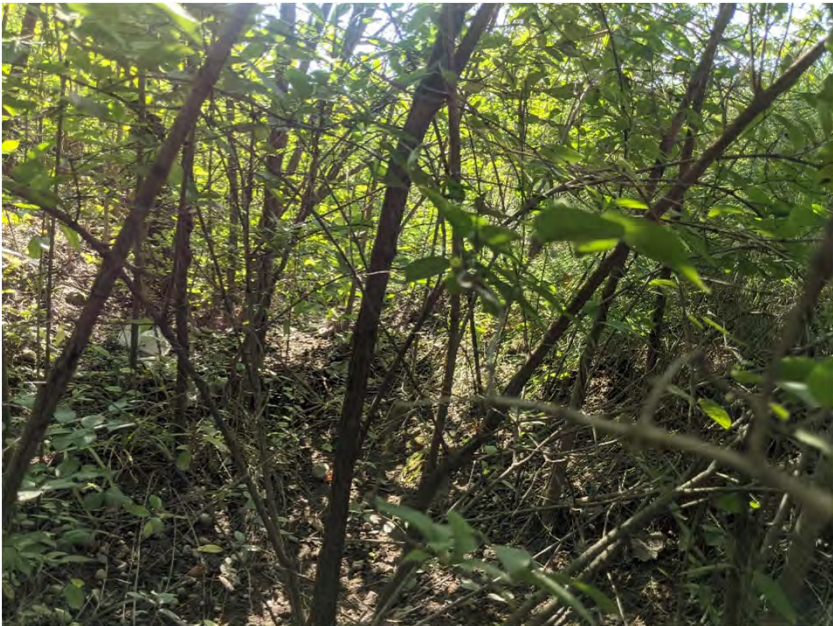
Photo 7. Looking southeast at the beginning of Drainage Swale 1 within the investigated area.

Drainage Swale 1 is located within a low-lying area that collects roadway drainage south of Epler Avenue and north of the access road within the aggregate plant. Drainage Swale 1 begins approximately 0.19 mile west of Belmont Avenue and extends approximately 30-feet northwest before terminating. The drainage swale was inspected and was determined to not exhibit defined bed and bank or a continuous ordinary high water mark.

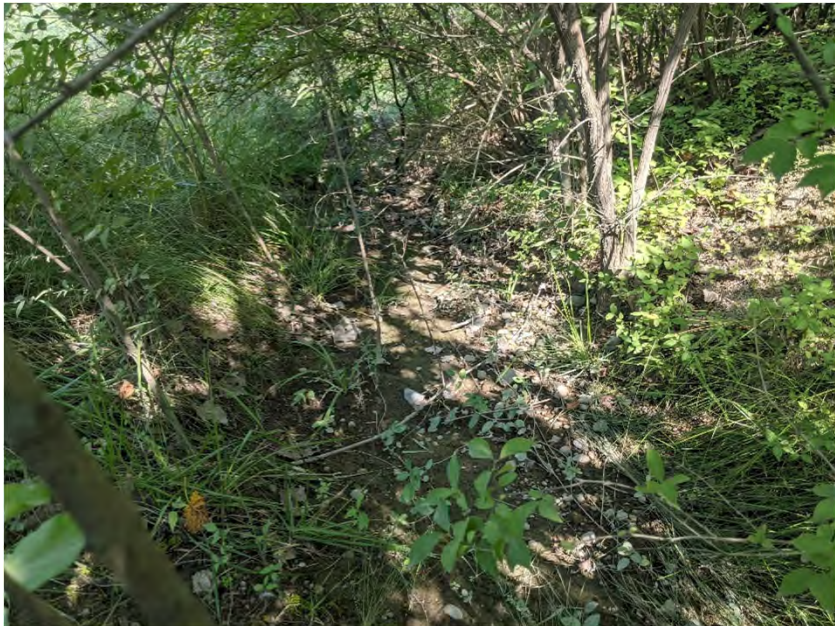
Photo 8. Looking northwest along Drainage Swale 1 within the investigated area.

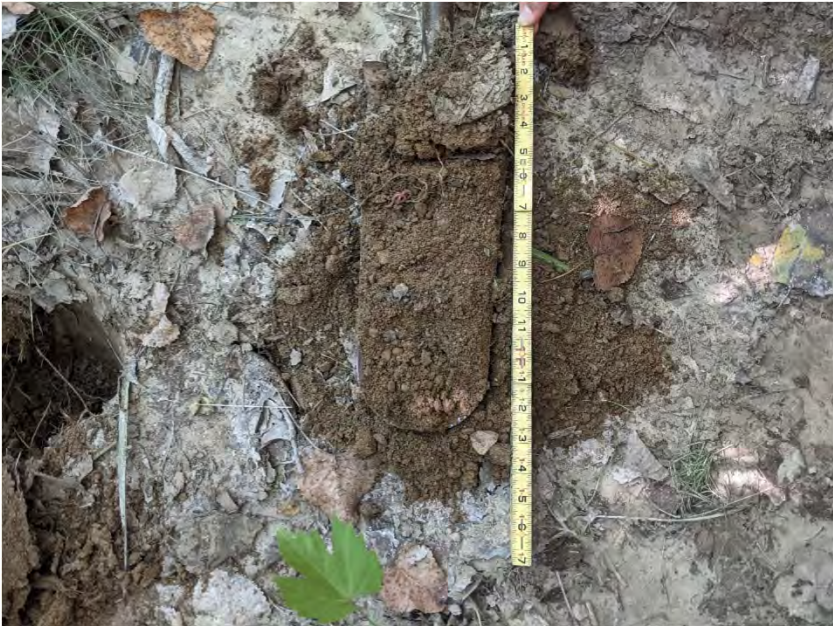
Photo 13. Looking at DP 1 located in the low-lying area north of the access road within the aggregate plant.

No wetlands were delineated within the investigated area. The investigated area was thoroughly reviewed for areas of hydrophytic vegetation and wetland hydrology. One data point (DP 1) was collected in an area that had exhibited hydrologic indicators and was located in a low-lying area surrounding a culvert inlet and outlet. DP 1 is located approximately 0.22 mile west of Belmont Avenue and 0.01 mile south of Epler Avenue. The dominant vegetation consisted of *Cornus drummondii* (FAC) and *Lonicera morrowii* (FACU) within the sapling/shrub stratum. Hydrologic indicators included Sediment Deposits (B2) and Drainage Patterns (B10). Although DP 1 possessed hydrologic indicators, it did not possess the hydrophytic vegetation or hydric soil to be determined a wetland.

Data Points Summary							
Data Point	Photos	Lat/ Long	Water Resource	Hydrophytic Vegetation	Hydric Soils	Wetland Hydrology	Within a Wetland
1	12-14	39.685385/ -86.200781	N/A	No	No	Yes	No

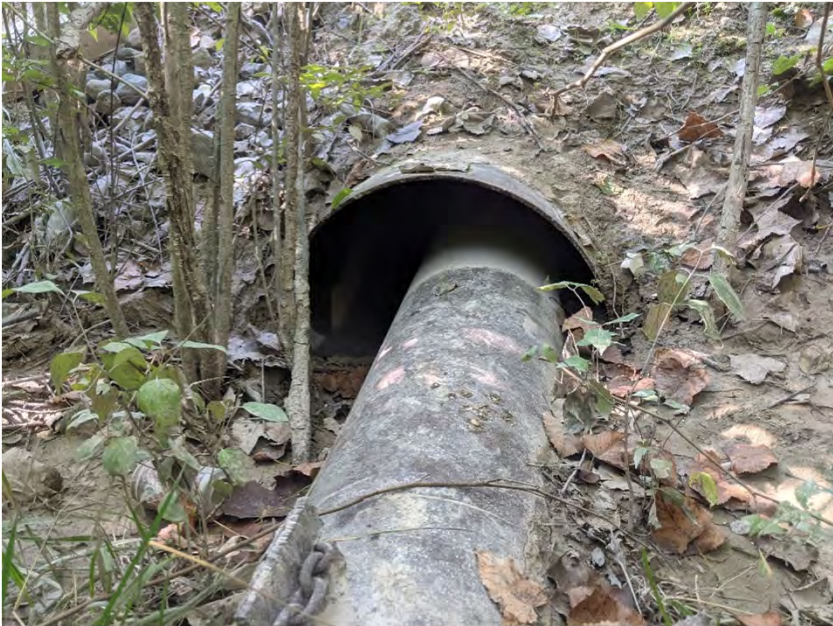
Photo 15. Looking south at the inlet of a culvert in the low-lying area north of the access road within the aggregate plant.

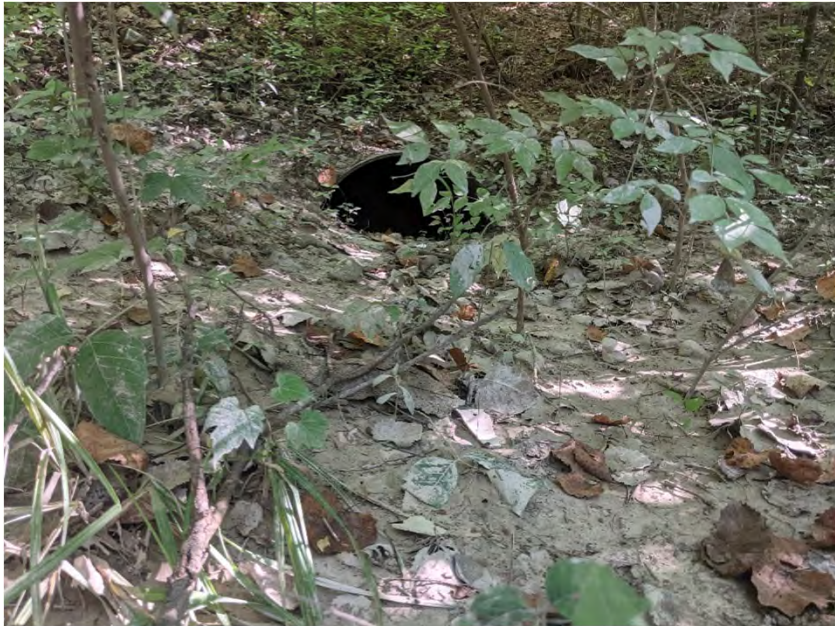
Photo 16. Looking north at the outlet of a culvert in the low-lying area north of the access road within the aggregate plant.

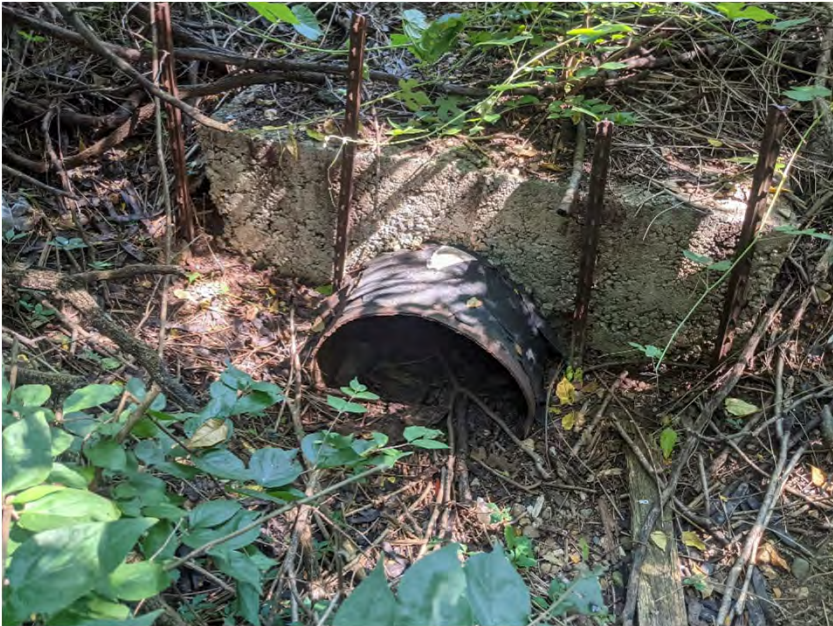
Photo 31. Looking north at the culvert at the beginning of Drainage Swale 2 south of Epler Avenue.

Drainage Swale 2 is located within a low-lying forested area at a culvert outlet south of Epler Avenue and north of the access road within the aggregate plant. Drainage Swale 2 begins approximately 0.01 mile south of Epler Avenue at a culvert outlet and extends approximately 14-feet south within the investigated area. Drainage Swale 2 extends south beyond the investigated area. The drainage swale was inspected and was determined to not exhibit defined bed and bank or a continuous ordinary high water mark.

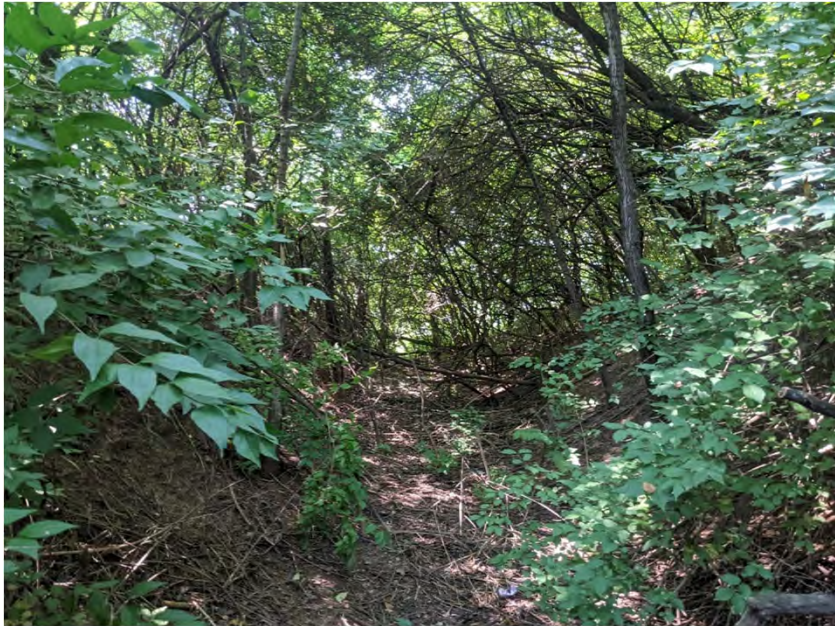
Photo 32. Looking south along Drainage Swale 2 south of Epler Avenue.
